SALT WATER DETECTION – LEYCO WATER SOFTENER

Water tastes salty and/or is milky

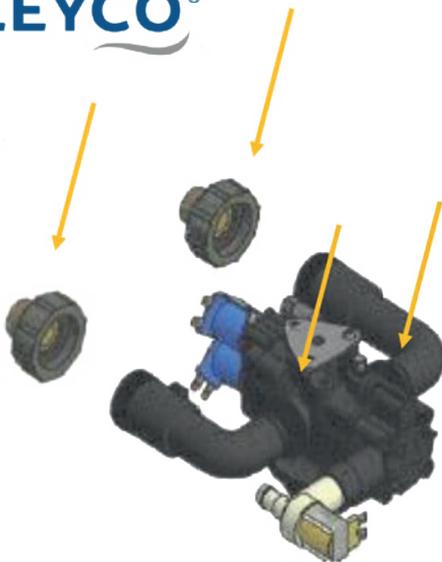
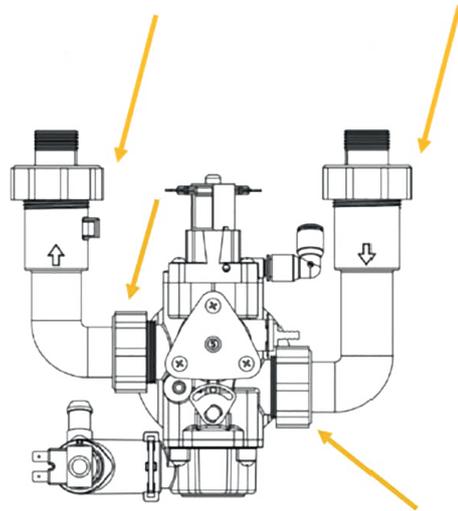
The salty taste in the house pipe is due to a leak. This means that water is getting into the salt tank unintentionally, often recognisable by the abnormally high level of water in the salt tank. Most of the time, there is a leak at the water inlet/outlet screw connections, due to looseness during installation.

As a general rule, all water-carrying connections should be checked for leaks!
